Oil Circuit Breaker Explosion

The incident occurred in a South African Coal Mine

September 2009

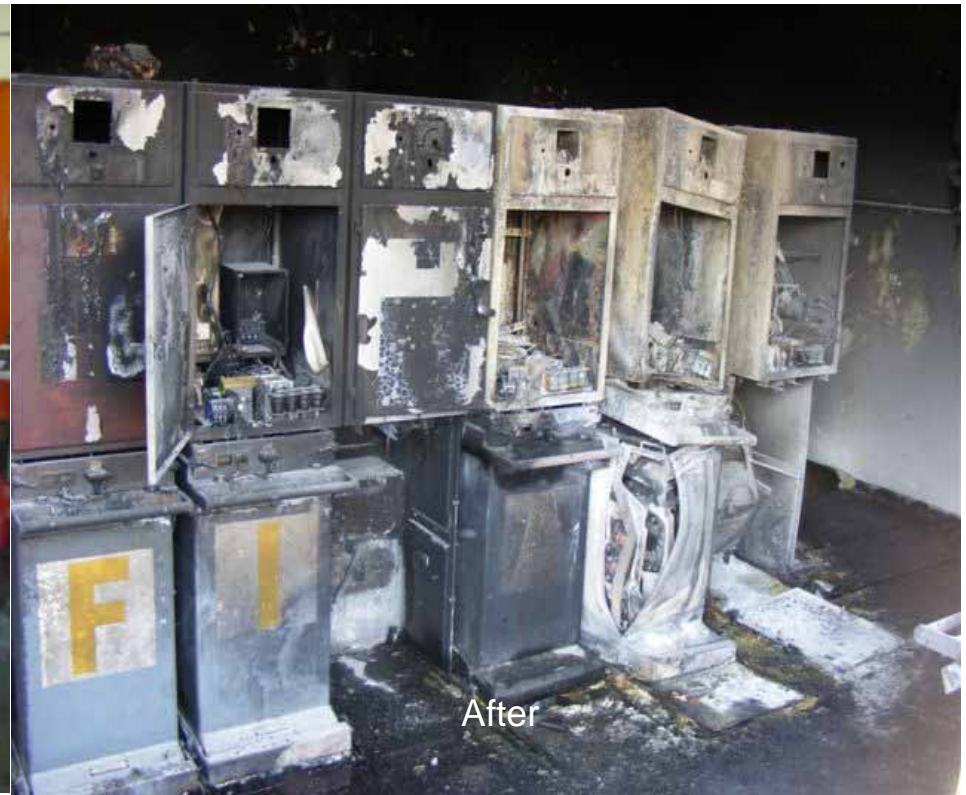
After

The authorised electrician undertook remote switching of an 11kV Oil Circuit Breaker (OCB) at the main substation. The OCB exploded, probably due to mechanical failure, and the resultant blast wave blew off the doors of the substation, and seriously damaged the building. The electrician broke his upper right arm when the door behind which he was standing was forced violently open. An intense fire followed, destroying all equipment within the substation.

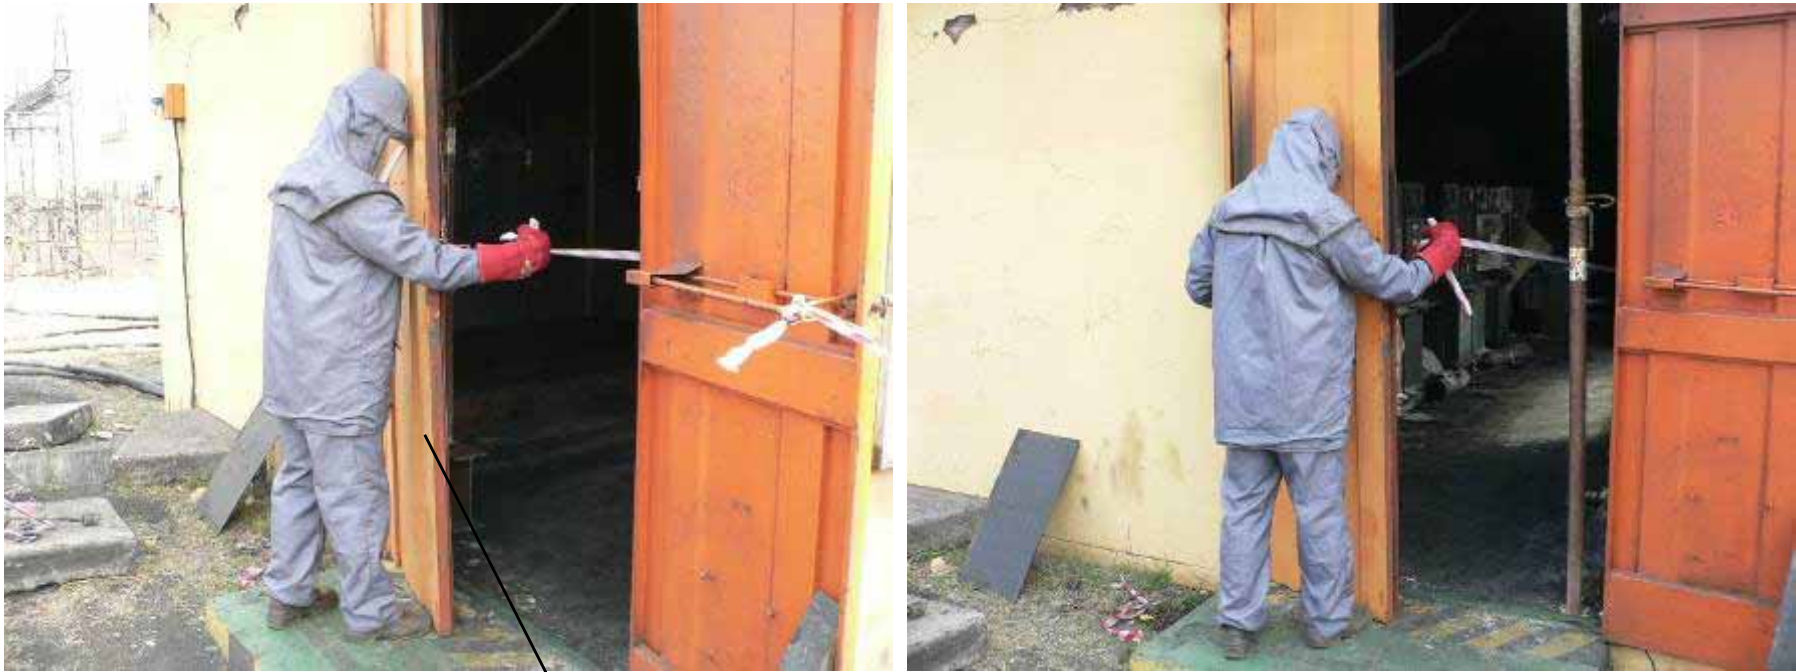
This door was latched, top and bottom, and exploded outwards

Position of electrician when switching. Note the flash-suit worn during operation.

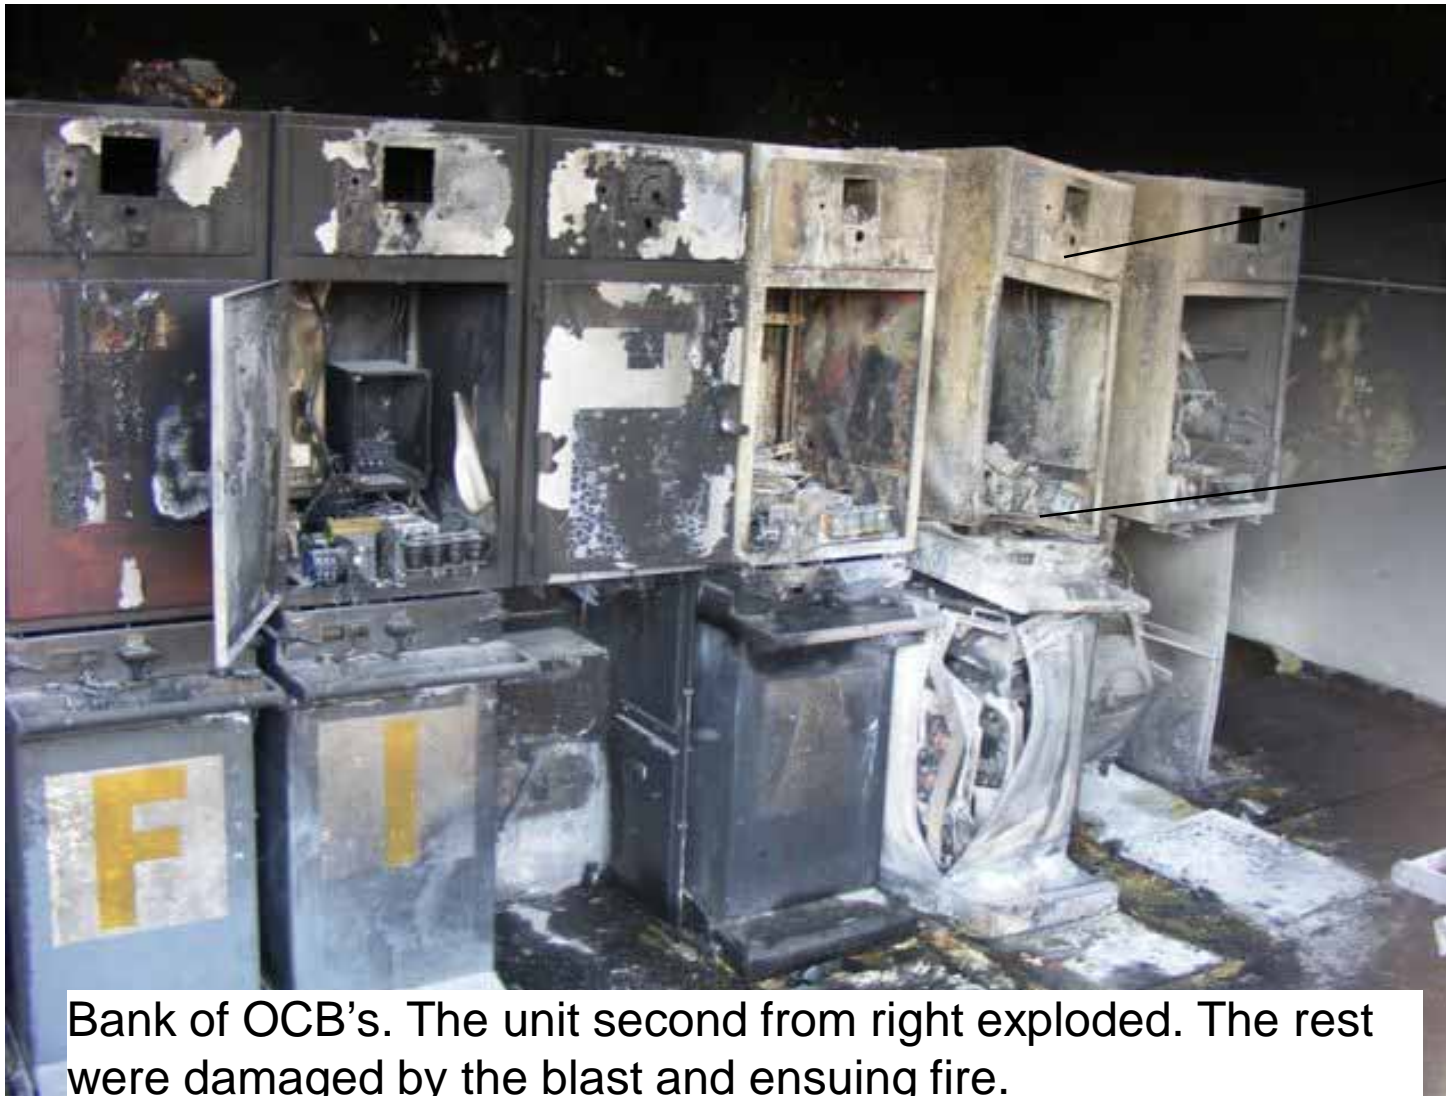
Relays housed in this unit

Breakers in this unit, submerged in oil. Note blast damage to steel casing.

Bank of OCB's. The unit second from right exploded. The rest were damaged by the blast and ensuing fire.

The contacts in the switchgear did not engage or disengage correctly in time to prevent prolonged arcing and subsequent oil vaporisation, which led to a violent explosion within the substation.

Action	By when
Replace all OCB's with modern technology (SF6 or vacuum)	31 August 2011
Ensure electrical remote switching is fitted to all medium voltage switchgear to allow for switching from outside the building (at a safe distance) in which the switchgear is housed	16 October 2009
Where OCB's are currently used, all baseline risk assessments must be reviewed to include mitigation strategies for explosions. The hierarchy of controls must be applied. Revise procedures accordingly	30 September 2009
Comprehensive testing must be done on all medium voltage switchgear. This includes oil testing, speed tests and testing of all mechanisms.	31 December 2009
Full flash suits must be worn when local racking and spring charging takes place on medium voltage switchgear	30 September 2009

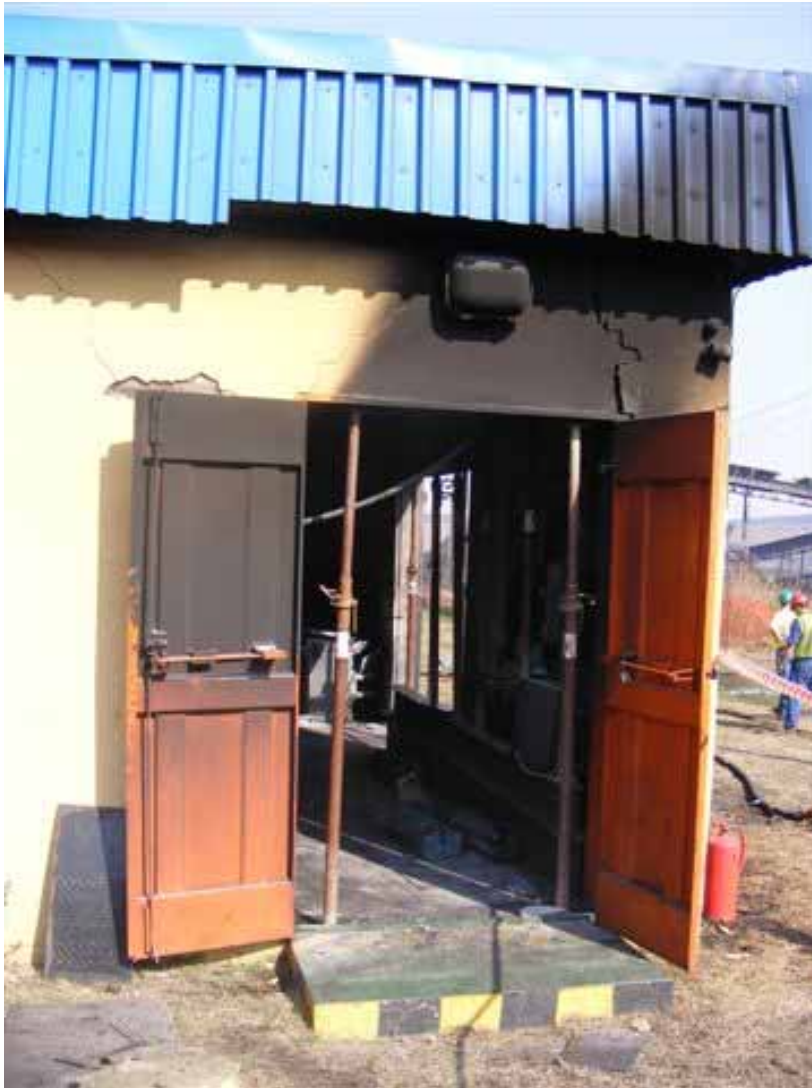
Left: Doors behind which electrician sheltered during switching. Note the cracks in the brickwork. Supports were installed after the event.

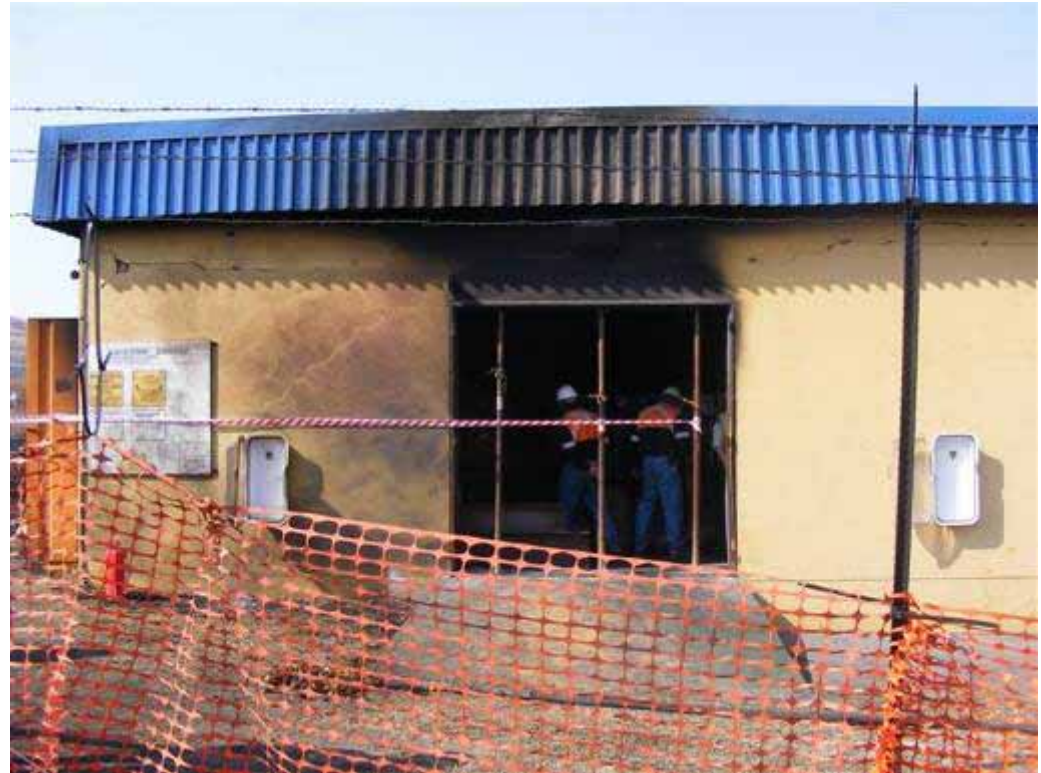
Above: Position of front doors. They were blown towards the camera position, and though a chain-link fence, the remains of which can be seen in the foreground.
