Oil Circuit Breaker Explosion

The incident occurred in a South African Coal Mine

September 2009

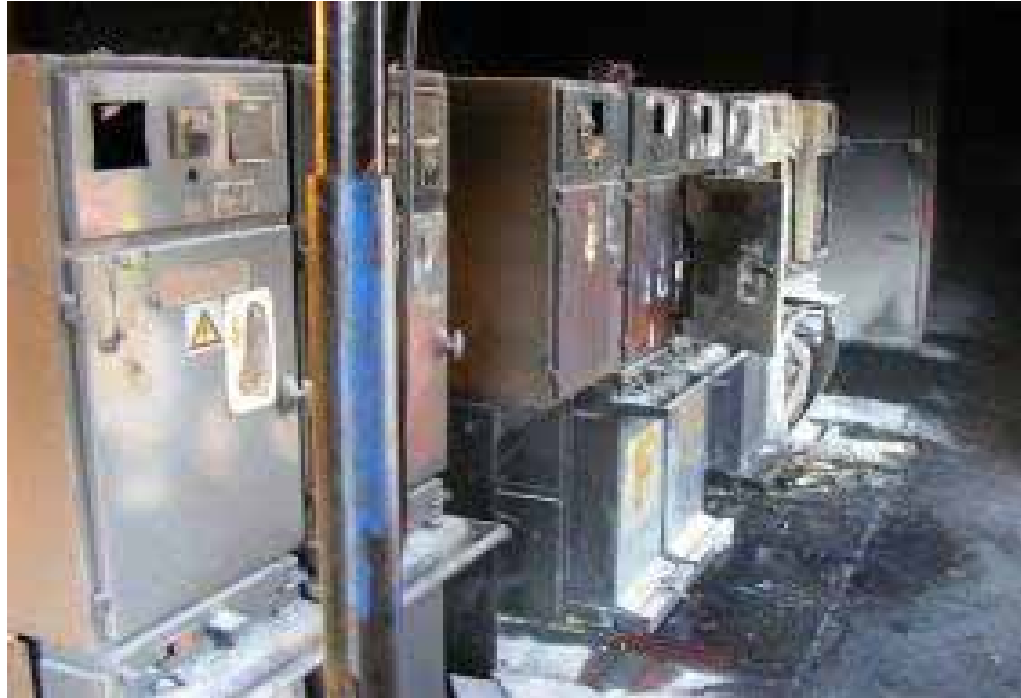
Diagram of substation layout

The authorised electrician undertook remote switching of an 11kV Oil Circuit Breaker (OCB) at the main substation. The OCB exploded, probably due to mechanical failure, and the resultant blast wave blew off the doors of the substation, and seriously damaged the building. The electrician broke his upper right arm when the door behind which he was standing was forced violently open. An intense fire followed, destroying all equipment within the substation.
